Starduster

MAGAZINE

JANUARY 1975

FIRST PLANS BUILT ACRODUSTER TOO FLIES - by Jim Osborne

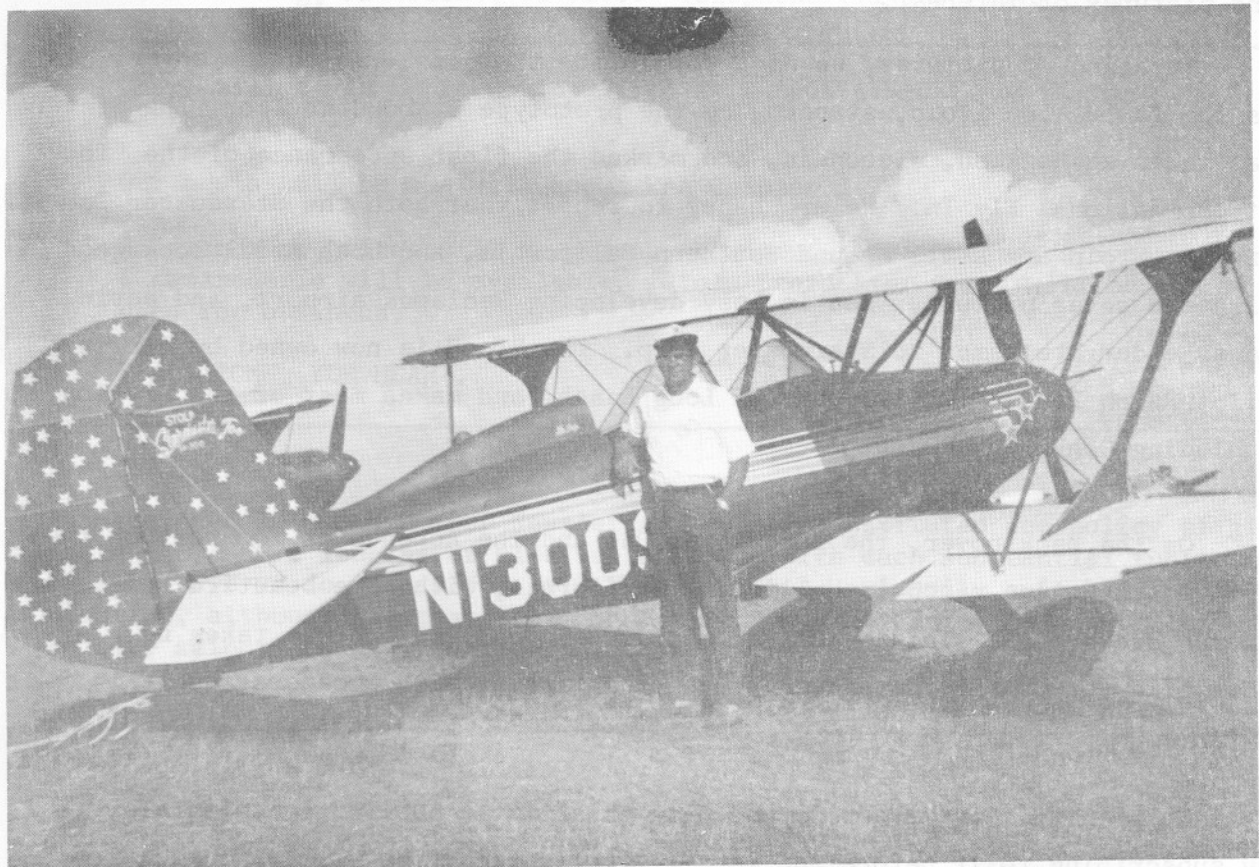
Speaking of pictures, we hope you notice the gentleman on the cover. It is the famous Lou Stolp, standing by the prototype Starduster Too. The picture was taken at Oshkosh, Wisconsin, and marked the first appearance of the "Too" at our National Fly In. We are happy to report that both the Starduster Too and Lou Stolp are still around Southern California, and both still look good, like the cover picture. Lou is busy developing Redlands airport, and acting as an elder Statesmen to Starduster Corp. The "Too" is now owned by Airline pilot Ralph Rina. It flies out of Long Beach, and makes most of the Fly Ins, including Oshkosh.

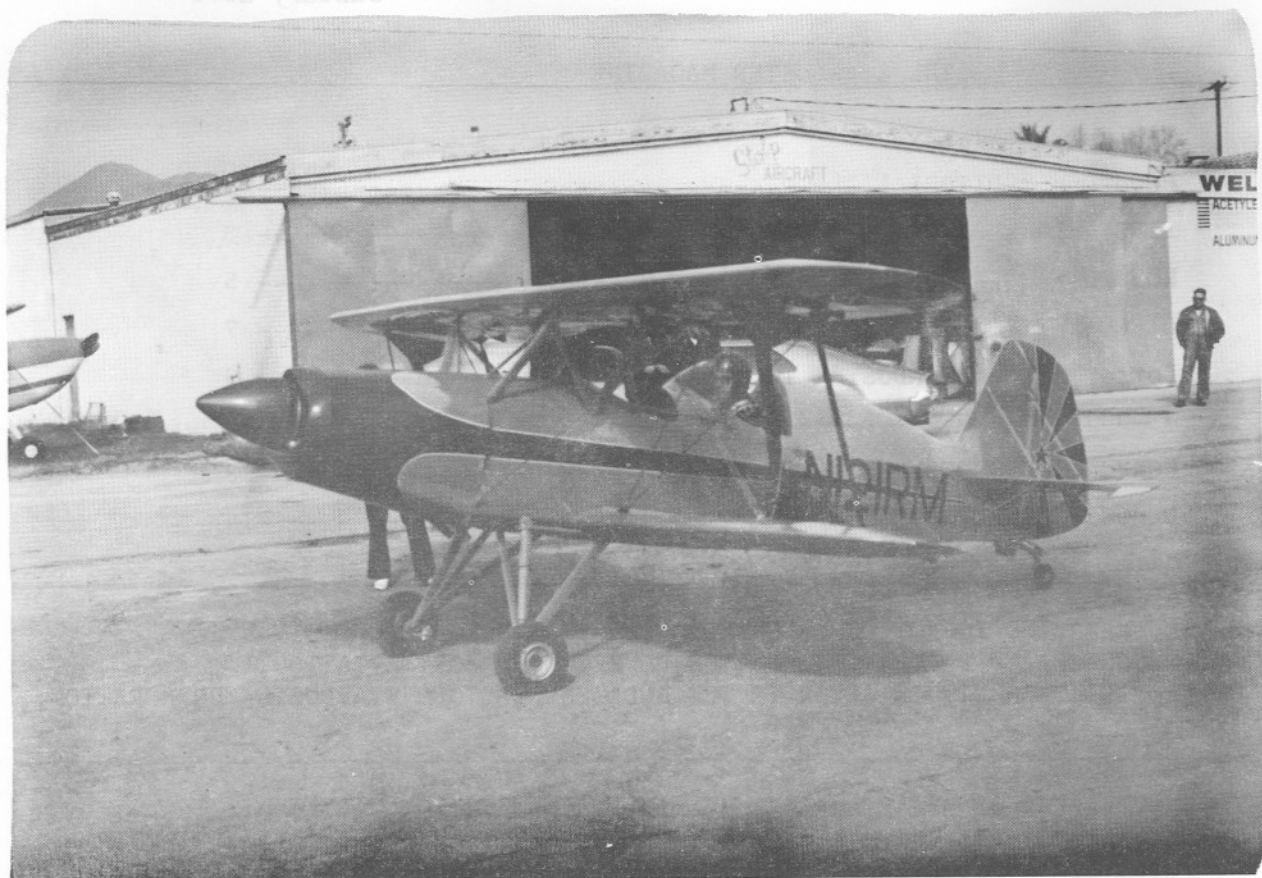
On Friday, Jan. 10, 1975, I had the privilege of making the first flight in Acroduster Too number N121RM, at Flabob Airport, Riverside, California.

Since the first flight, 5 hours has been put on the airplane. Further testing has established a maximum climb rate of 1800 feet per minute. This is still in the original configuration, and should improve when fairings and canopy are installed. Improvements are also expected as the engine wears in and loosens up a bit. Best rate of climb speed appears to be 95 MPH. Best angle of climb speed is 85.

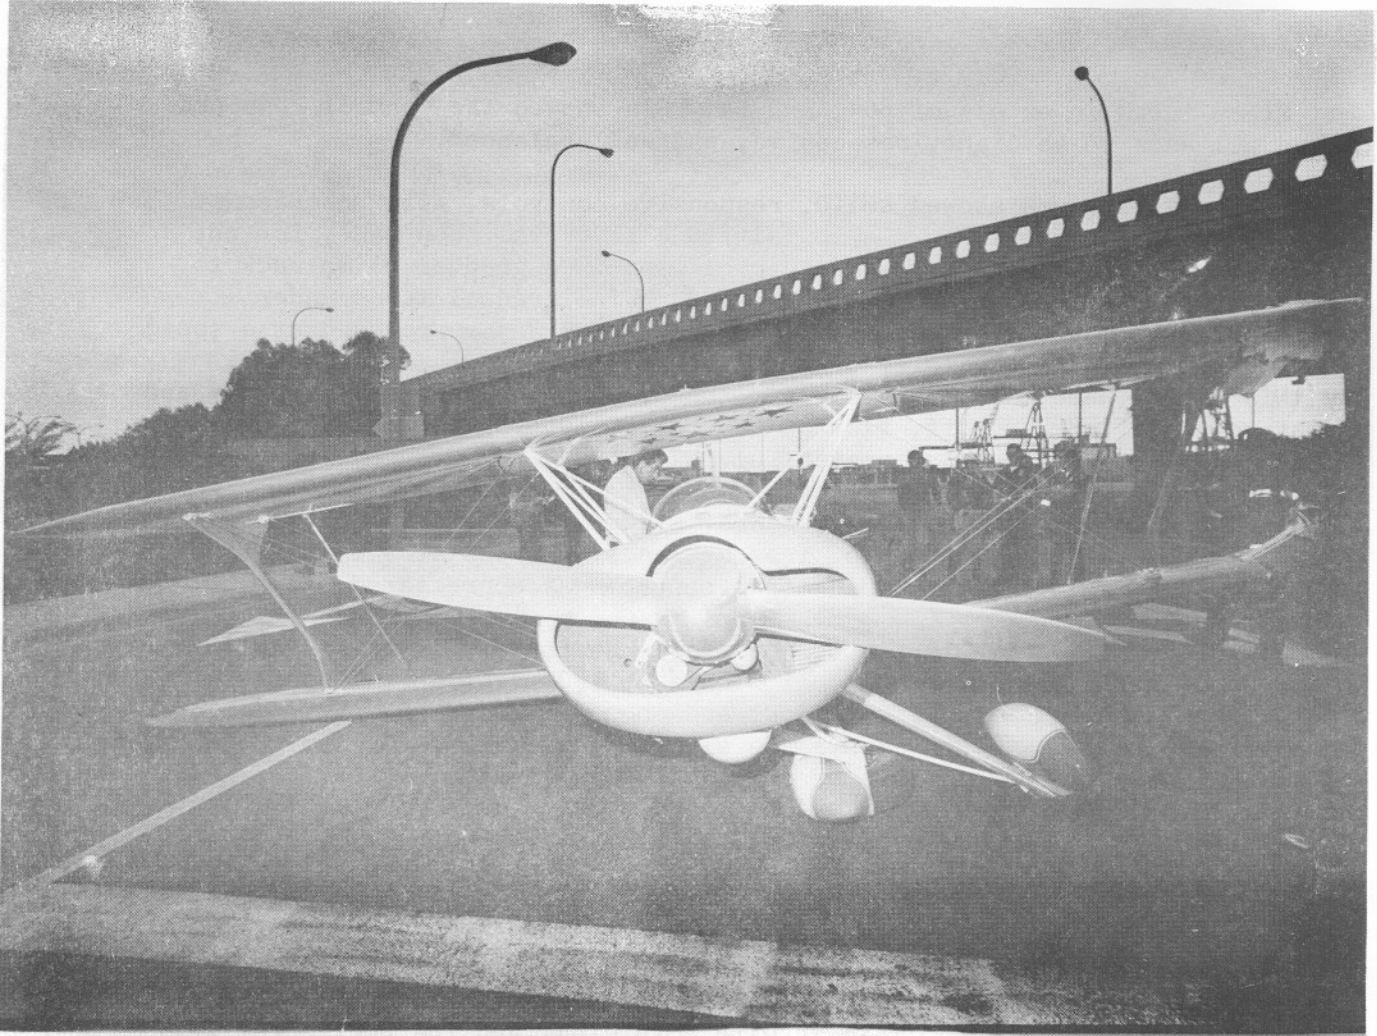
HOW TO MAKE A FORCED LANDING - While flying over the harbor, offshore from Long Beach, California, in Starduster Too N2MW, Mahlon Ward experienced a sudden and complete engine failure. He immediately turned towards shore and started making a series of correct decisions. His first decision was to resist the temptation to try to stretch his glide, and to maintain his airspeed at 75 MPH. After several futile attempts to start the engine, this airspeed brought him in over the beach about one block away from the Queen Mary, and at an altitude of approximately 150 feet.

By this time, his excess speed was dissipated, and immediately after making the turn he made a normal Landing. During the rollout, the last hazard appeared directly ahead. The road disappeared under a Freeway under pass. Electing to continue straight ahead, Mahlon entered the underpass. In the gloom under the Freeway, the left wing tips encountered a light post. The Starduster spun around and the right

gear collapsed. Damage was confined to left wing tips, & right gear.

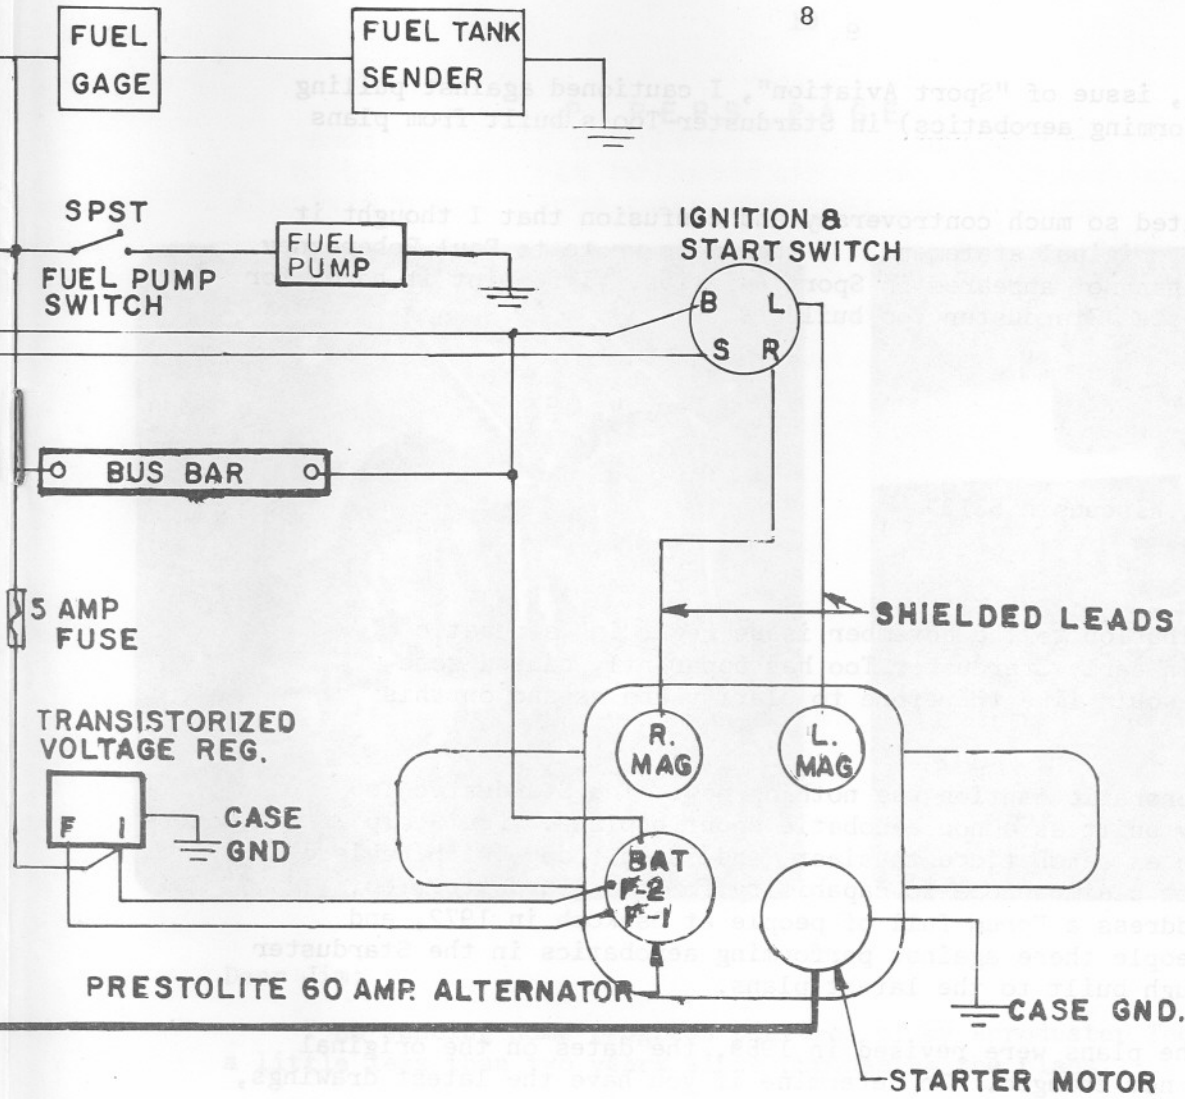
SCALE: NONE	SIMPLIFIED COPY WIRING DIAGRAM	THE STARDUSTER MAGAZINE
DATE: 1-30-75		
DRAWN: J. Osborne	FOR SA750 N121RM	
STRESS: N/A	STOLP STARDUSTER CORPORATION	
CHECKED: JB

5. SECONDARY WIRING SIZE 16.
 4. MAINLINE WIRING SIZE 10 OR 12.
 3. CABLE IN STARTER CIRCUIT MUST BE SIZE 0 OR LARGER.
 2. GROUND STRAP REQUIRED ACROSS DYNAFOCAL MOUNT RUN
 1. DESIGNED BY STARDUSTER MECHANIC GEORGE BAILEY
- NOTES:

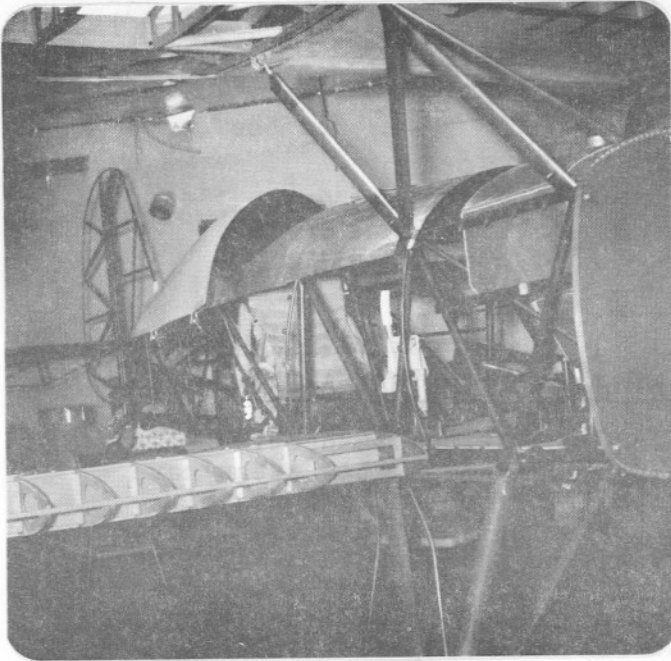
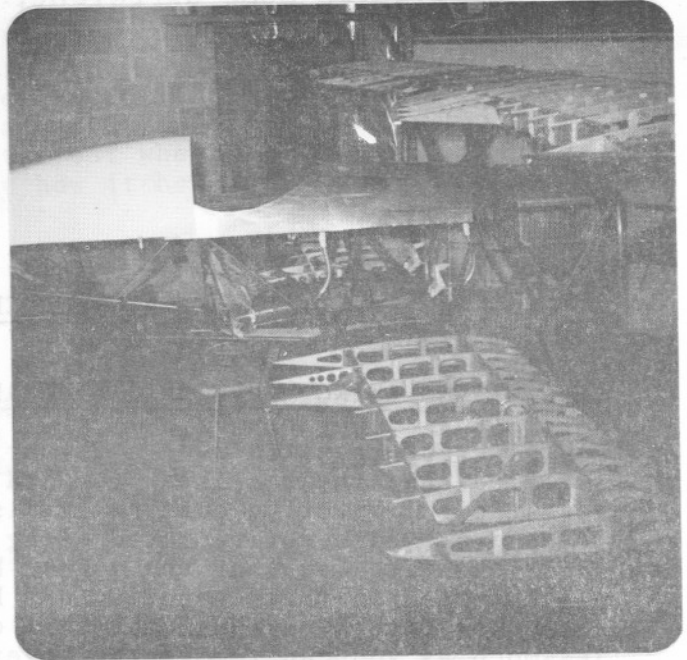
I am sending some progress pictures of my Acroduster Too. These represent a little less than two years since purchasing the plans.
