APRIL 1981

Starduster

DEDICATED TO THE ACTIVE HOMEBUILDER

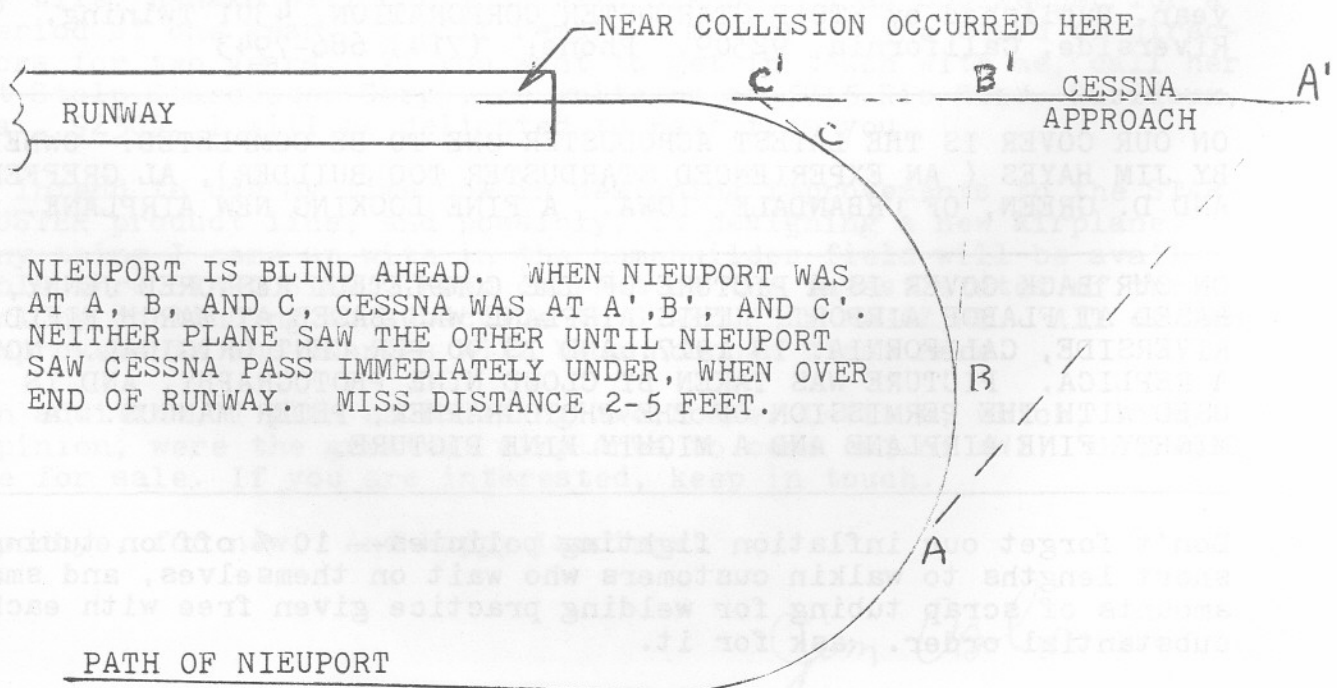
In talking to the cessna pilot, D.P. learned that the cessna driver had never seen the Nieuport, either during landing, rollout (when the Nieuport was off the wingtip, or during taxiing. The cessna pilot was an old man, retired military, with over 30,000 hours. He had been making a long straight in approach behind the cessna that D.P. had been following in a tight landing pattern. The 180 degree turn of the Nieuport had apparently exactly tracked the motion of the cessna so that it was constantly dead ahead and in the Nieuports blind spot. See sketch below.

I think the moral of the above two stories is that steady turns or steady straight and level flight both are dangerous when flying an airplane that is blind ahead. In order to be safe we need to S turn in flight and landing pattern turns should be restricted to no more than 90 degrees. If the D.P. in the Nieuport had made two 90's in place of the one 180, the Cessna would have run out from behind the nose blind spot.

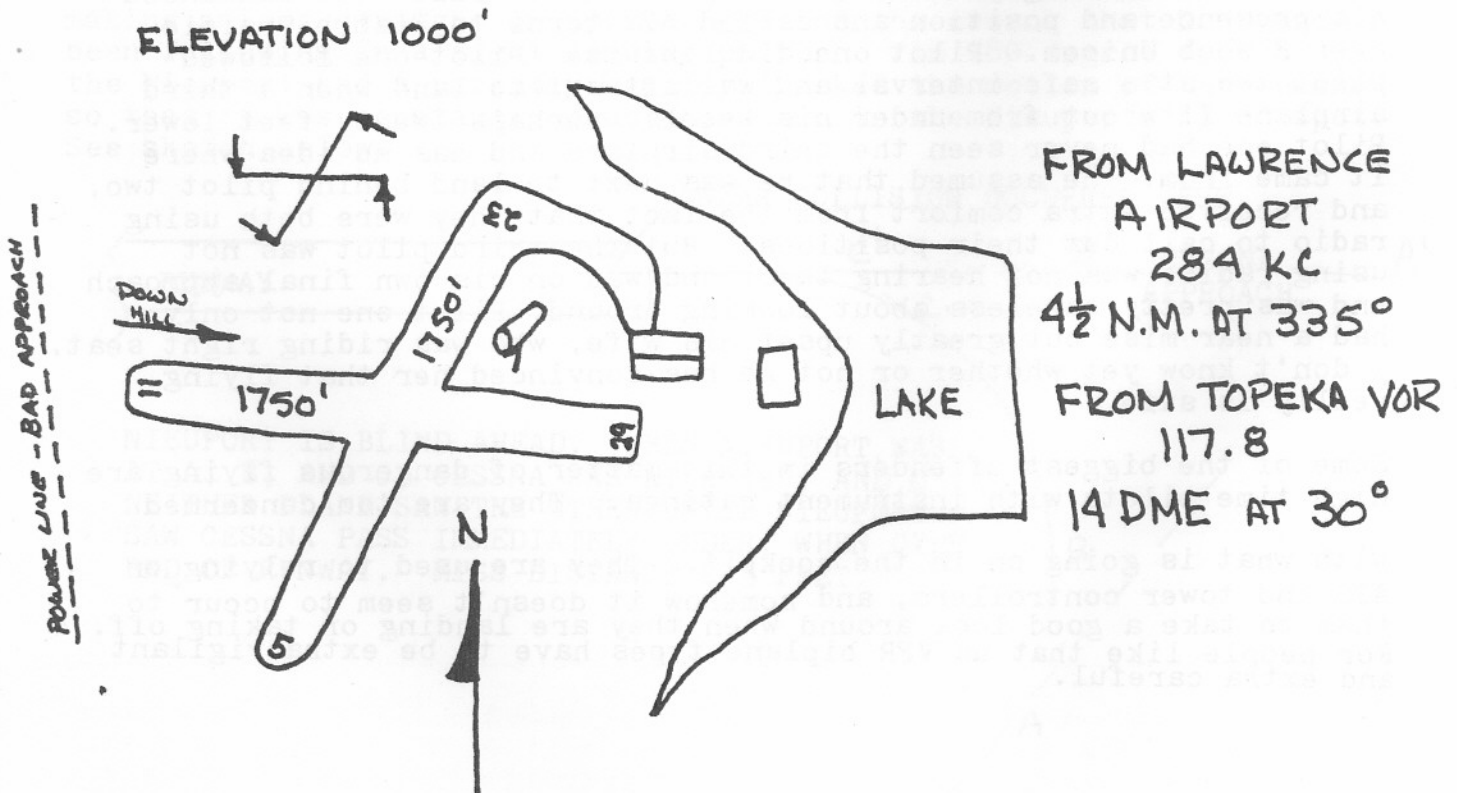
Bar-G has two grass strips with undulating contours.
Approaches are described below. Be careful and suggest
initial low pass to look it over. We land our Bonanza here.
Land at your own risk. Not responsible for accidents.

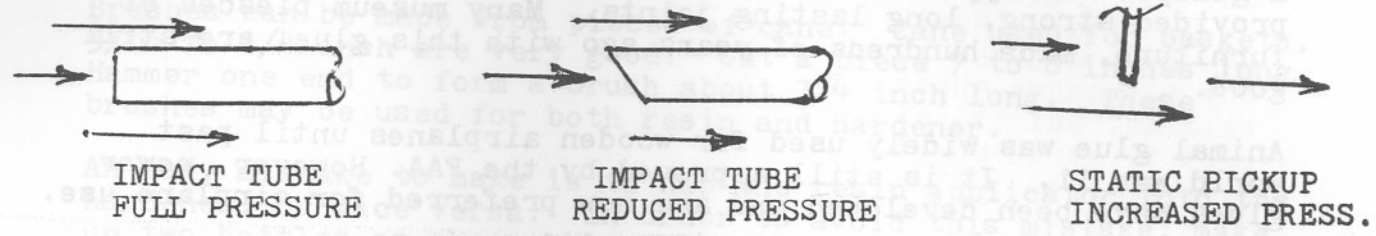
Another approach with the impact tube is to trim the opening so it makes an angle with the slipstream. A 90 degree opening will give you true impact pressure. A parallel opening will give you approximate static pressure. So, to reduce impact pressure, have the opening something less than 90 degrees. See below.

One problem with both the rubber grommet, and the biased cut impact opening is that, while they will enable you to correct any airspeed error, they don't do a thing for any altimeter error that may be caused by a low pressure static pickup. A low static pressure will make your altimeter read higher than it should. This is generally not a serious error for VFR pilots and airplanes, but is something to consider. It can also create a small error in your rate of climb. To get all your air pressure instruments reading correctly would require you to get proper impact pressure and then experiment with the static pressure pickup until the airspeed reads correctly. If you have good instruments, then the altimeter and rate-of-climb should also read correctly.

But for a quick and easy airspeed correction, the grommet around the impact tube or cutting the tube on a bias work fine.

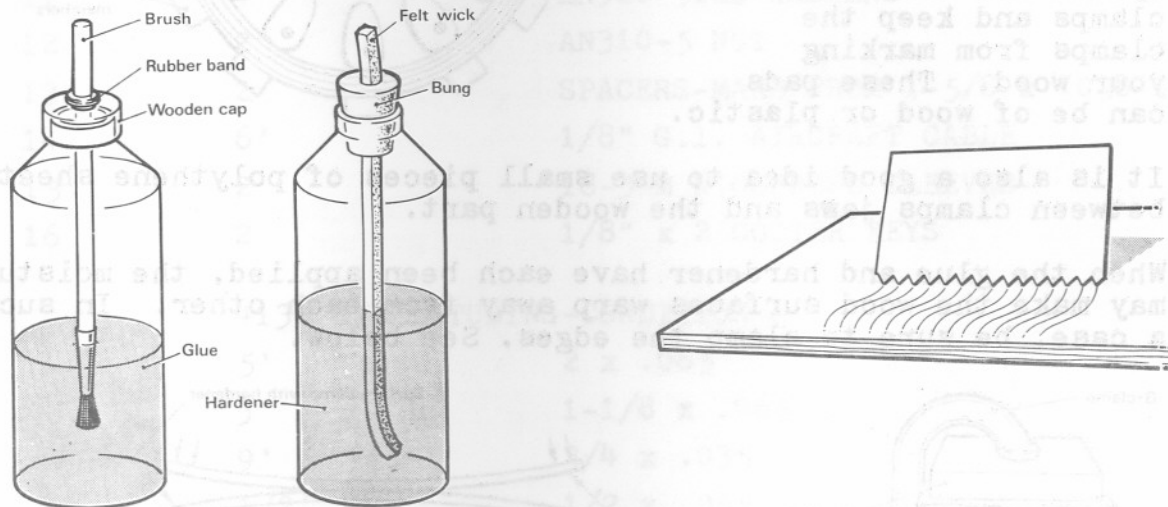
An easy mistake to make is to dip the resin applicator into the hardener, or vice versa. In order to avoid this mistake, make up two bottles as shown below. Obtain the bottles from empty bleach, detergent, or toilet containers. Make a wooden cap for one of the containers, and fit it with a brush, as shown. Make a bung stopper for the other bottle, with a felt wick going thru the bung. This container will hold the hardener. The felt wick protrudes from the bung and makes a very convenient applicator.

To apply resin over a large surface area, a piece of plastic sheet with a toothed edge, as shown above on the right, is very handy. It is worth the trouble to make such a "comb" with teeth the proper depth to give a good glue spread.

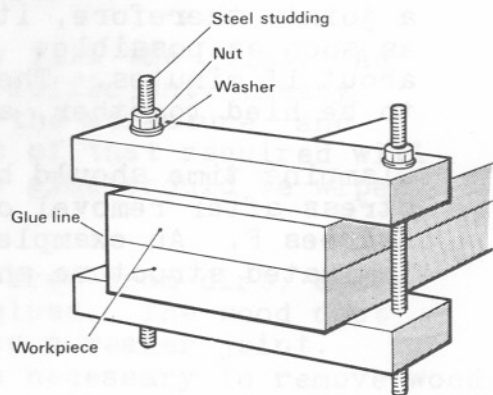
Easily made homemade clamp shown at right.

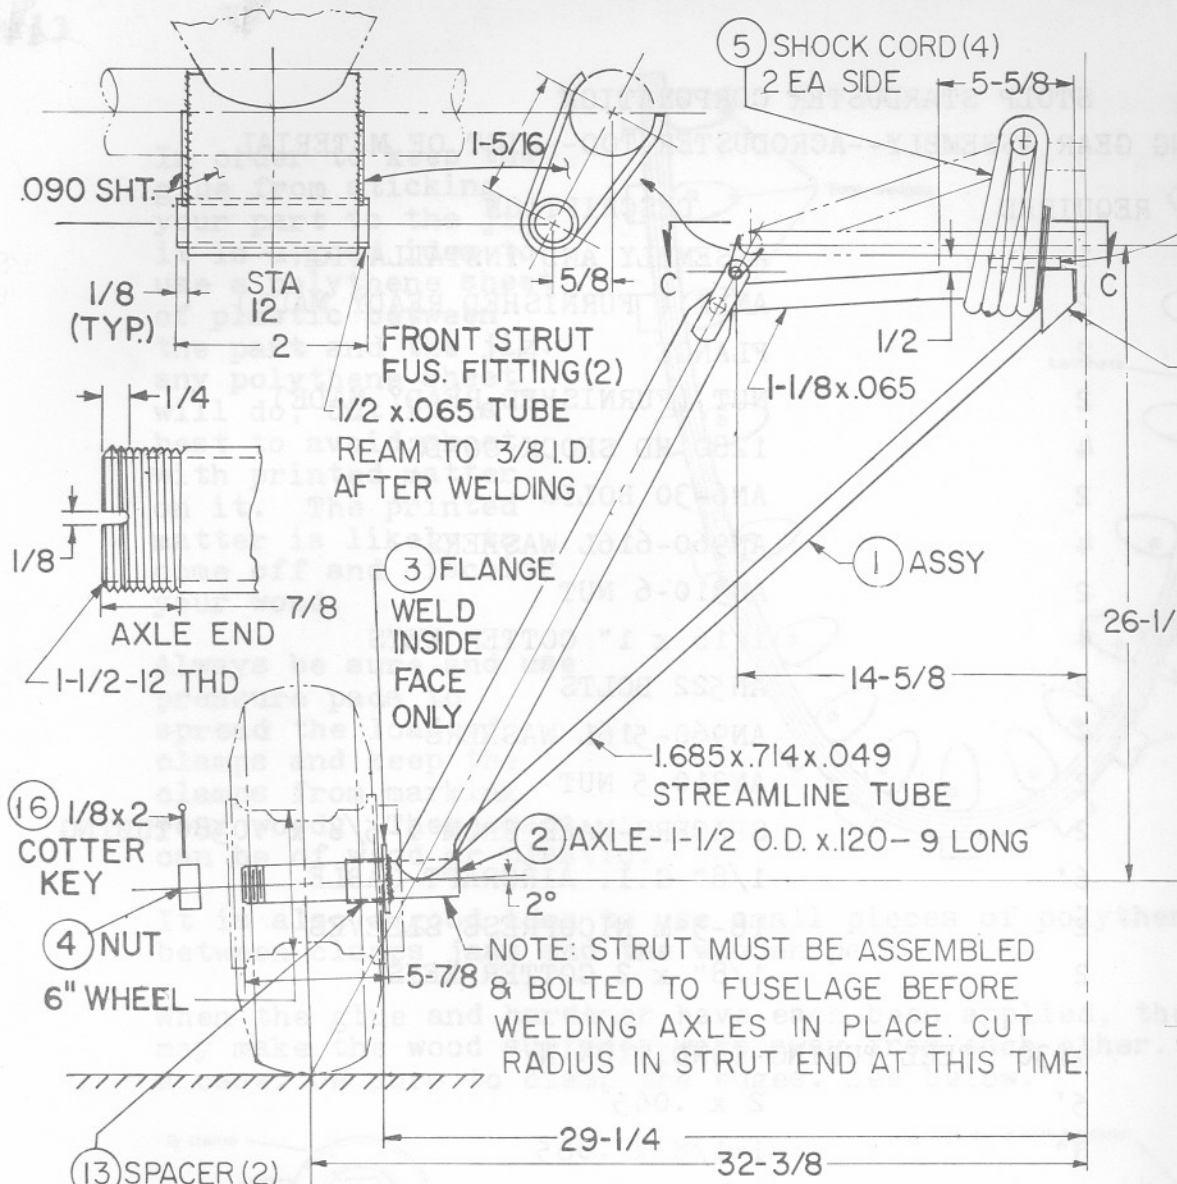
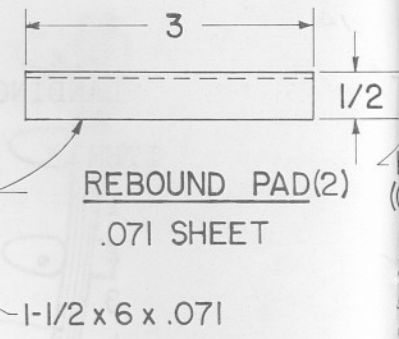
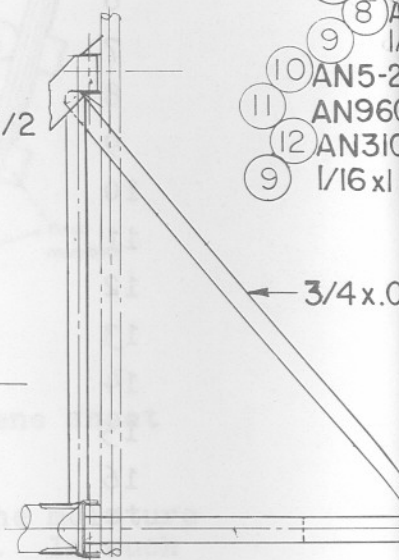
SCALE 1/4"	ASSEMBLY-	
DATE 3-22-52	LANDING GEAR	
DRAWN J. G. G.	MODEL SA 750	
CHECKED J. G. G.	STOLP STARDUSTER CORPORATION	
	1201 TOWING, THUNDERBOLT ROAD	SHEET NO. 3

STOLP STARDUSTER CORPORATION
 LANDING GEAR ASSEMBLY--ACRODUSTER TOO--LIST OF MATERIAL

CAUTION : DO NOT HAVE THE SAFETY CABLES TOO TIGHT-ALLOW 4" OF MOVEMENT-RESTRICTED MOVEMENT WILL RESULT IN GEAR DAMAGE ON THE FIRST HARD LANDING.

VIEW A
 REAR STRUT WELDMENT
 ALL PLATES ARE .090

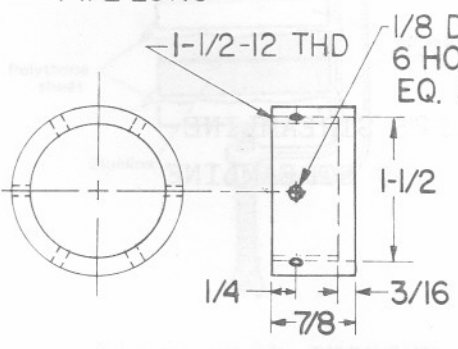
VIEW C-C

- 1- WELD THIS ON
- 2- FLATTEN WITH TORCH & HAM
- 3- WELD THESE

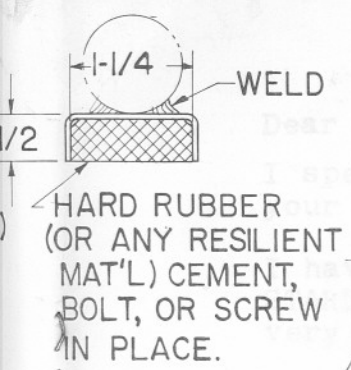
VIEW B
FRONT STRUT
ALL PLATES A

- (6) AN5-22
- (7) AN5-22
- (8) AN5-22
- (9) 1/16 x 1
- (10) AN5-22
- (11) AN960
- (12) AN310
- (9) 1/16 x 1

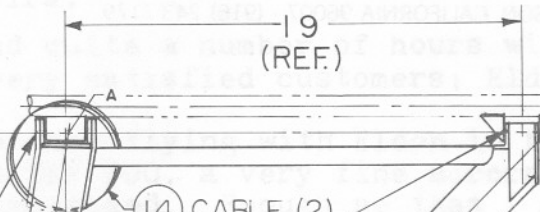
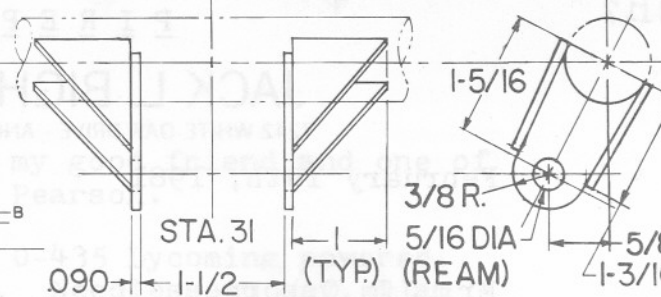
- 6 AN6-30 BOLT (2)
- 7 AN960-616L WASHER (4)
- 8 AN310-6 NUT (2)
- 9 1/16x1 COTTER KEY (2)
- 10 N5-22 BOLT (2)
- 11 AN960-516L WASHERS (4)
- 12 AN310-5 NUT (2)
- 13 1/16x1 COTTER KEY (2)

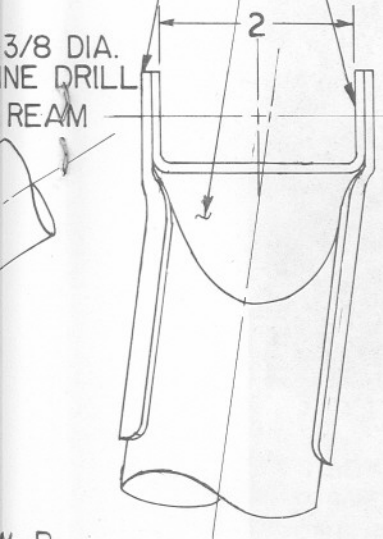
REAR STRUT FUS. FITTING
MAKE FROM .090 SHT.

4x.035

DRILL FIRST
WITH
HAMMER
EASE LAST.

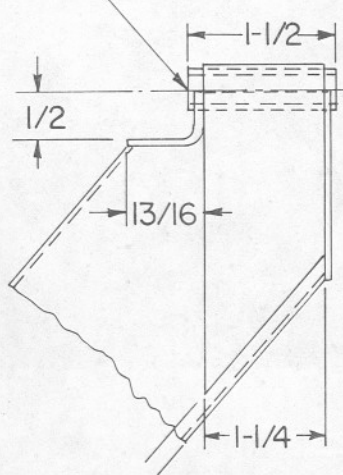
7/16-.065 TUBE
REAM TO 5/16 DIA.
MAKE 1-3/4 LONG.
FILE TO 1-1/2
AFTER WELDING

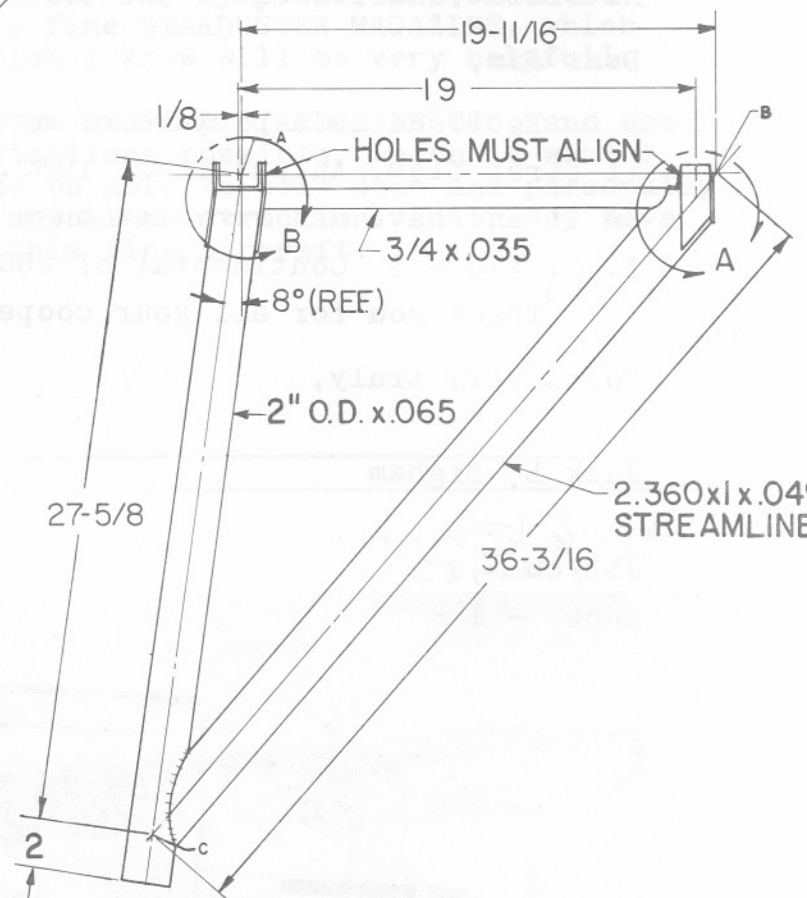
VIEW A

REAR STRUT WELDMENT
ALL PLATES ARE .090

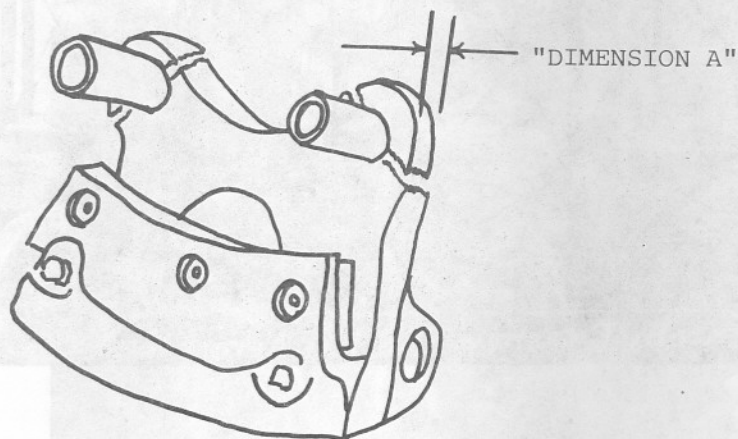
MODEL 30-9
MFG 12-73
CLEVELAND

The sketch shows the Cleveland Brake that was installed on my Pitts.

Since I had another set of wheels and brakes in the shop, I decided to replace both wheels and both brakes. Comparing the broken brake with the new one, I was surprised to find that dimension A on the broken assembly is approximately $3/8$ ". However, on the newer assembly, it is $3/4$ ". Both brakes are still the same model 30-9.... just different manufacturing dates.

I turned in a defect report to the FAA and am going to send a copy of this letter to Cleveland, just to let them know that somebody out here got stung by a design that they apparently knew was inferior since they subsequently doubled the Dimension A thickness.

After my experience, I will advise all members to replace the old "thineared" brake assemblies with the later mfg. dated brakes, with the ears that are approximately 3/4" thick.

The particular change you note in your letter was the result of a standardization program in 1975. The old style anchor pin used on the early 30-9 brake was replaced with a more common anchor pin used in the majority of our brake assemblies. The standard anchor pin necessitated the increased thickness at the lugs to function properly.

THE FAA MDR history for the last six years was reviewed to obtain an indication of the 30-9 performance. There have been four reports of incidences with this brake, one of which was yours. There was one other difficulty similar to yours, the other two were unrelated. The brake location on a Pitts, six o'clock position on the strut, puts the brake in a very susceptible position. As you know, the brake is an external design in which the brake extends beyond the wheel O.D. Being in this position, many occurrences could cause damage to the brake; flat tire or hard landing (the tire would hit the brake), collision with a rock or other item on the runway, etc. We recommend that the brake be mounted in the three or nine o'clock position.
